5 January 2016

RE: Field Activity Report
San Jacinto River Waste Pits
Remedial Investigation/Feasibility Study Oversight
Channelview, Harris County, Texas
Contract: EP-W-06-004
Task Order: 0130-RSBD-06ZQ

**FIELD ACTIVITY REPORT
23 AND 28–31 DECEMBER 2015
SAN JACINTO RIVER WASTE PITS
CHANNELVIEW, HARRIS COUNTY, TEXAS**

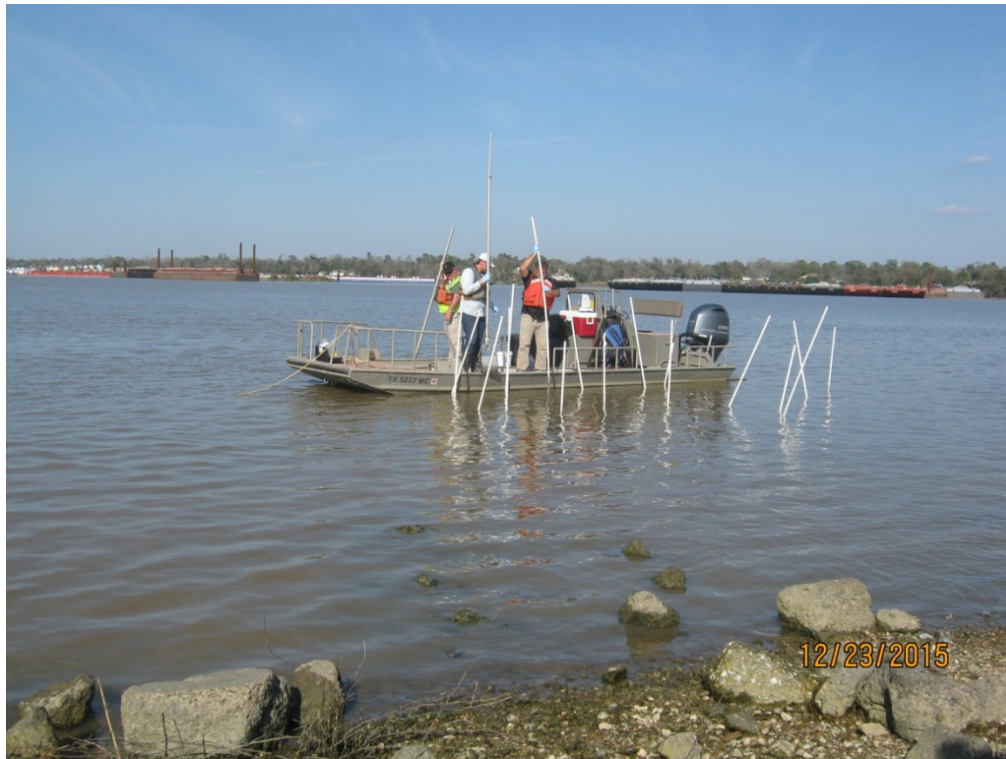
23 December 2015: Probing of armored cap for sediment sampling locations.

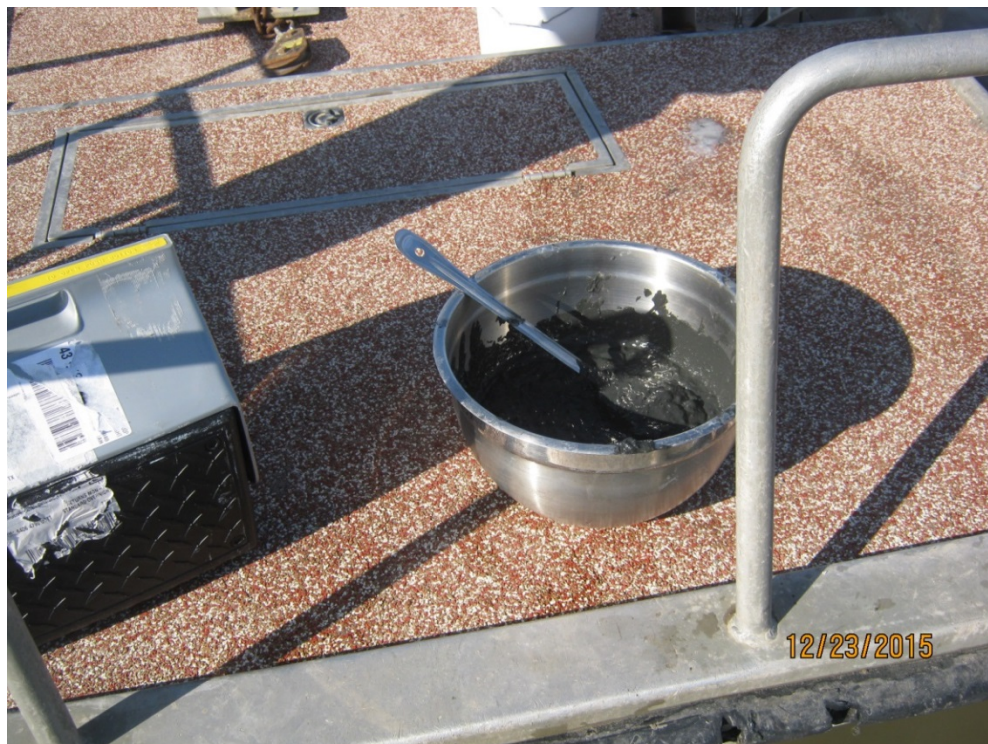
Collection of sediment samples was hindered by the presence of rocks (suspected of being part of the cap) and oyster shells. It was determined that samples would be composite samples versus grab samples due to the low volume of sediment retrieved with the sampling equipment.

23 December 2015: Typical material collected for sediment sample analysis.

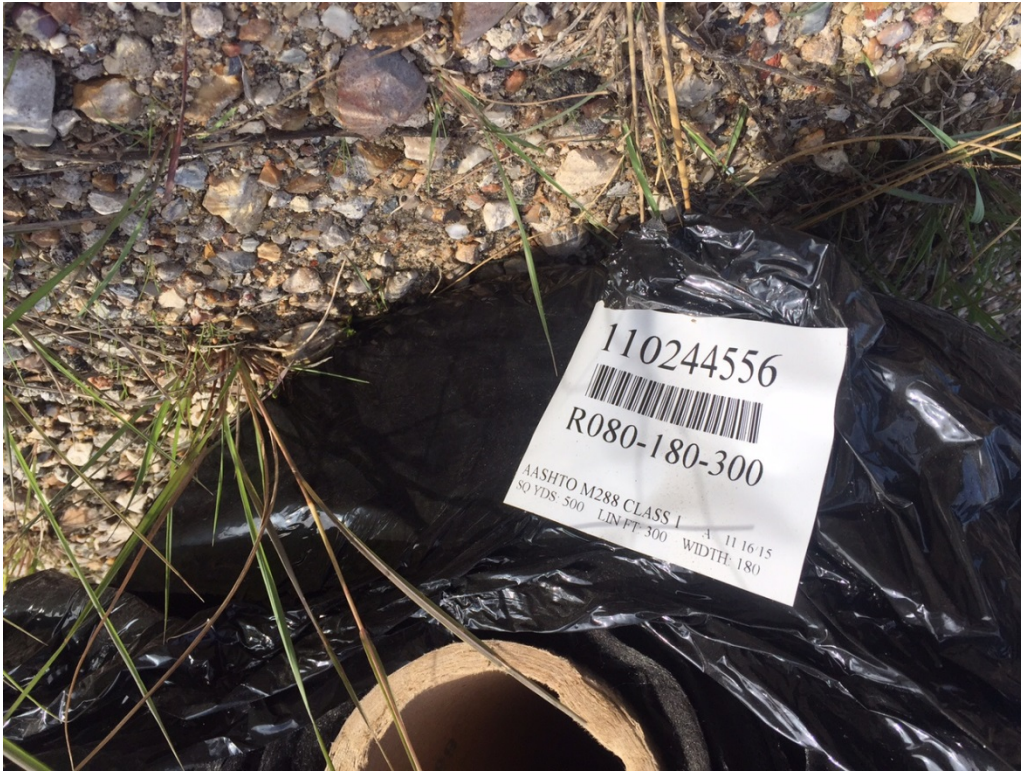
29 December 2015: Label from Geotextile Fabric Material to be used on armored cap.

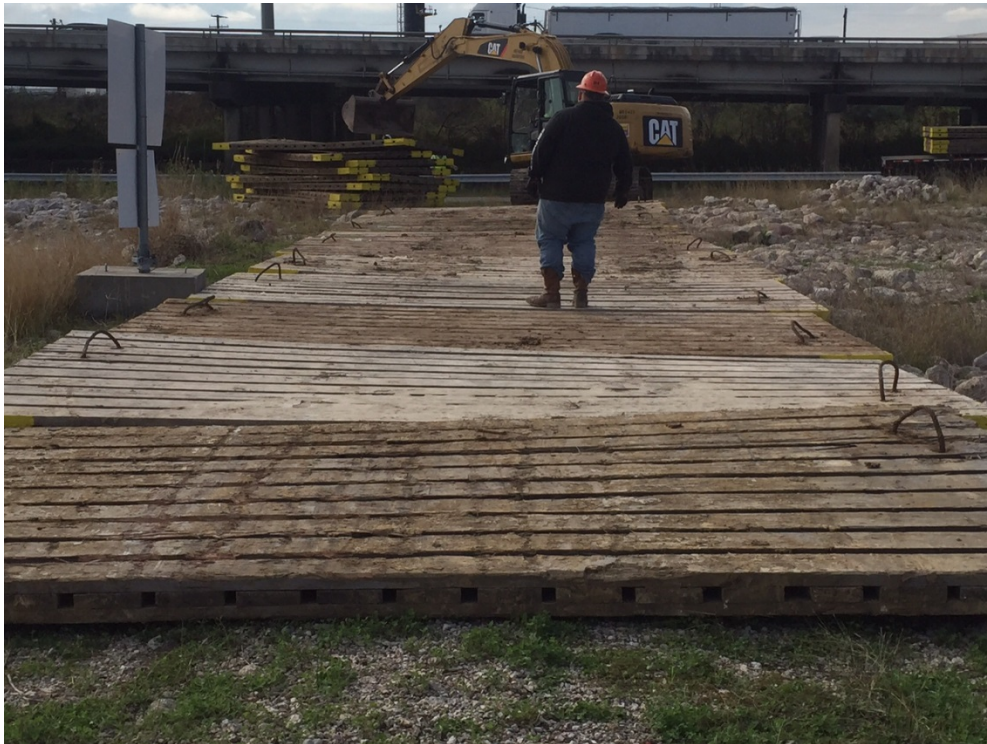
29 December 2015: Typical placement of wooded mats for equipment movement across the site.

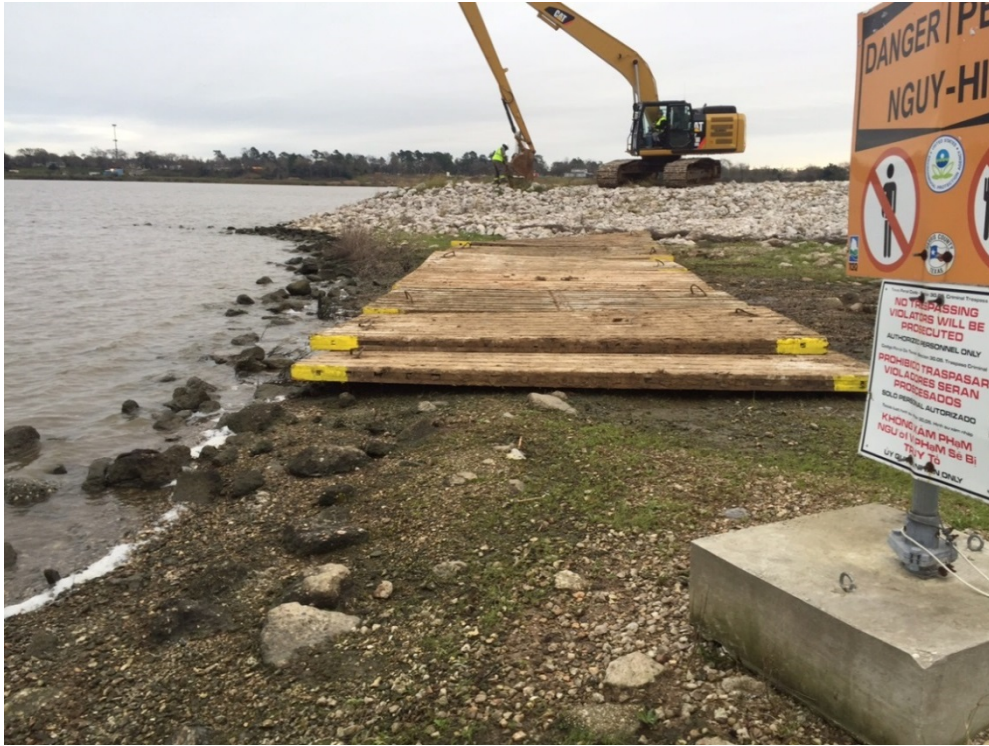
30 December 2015: Placement of wooded mats for the working area along the shoreline.

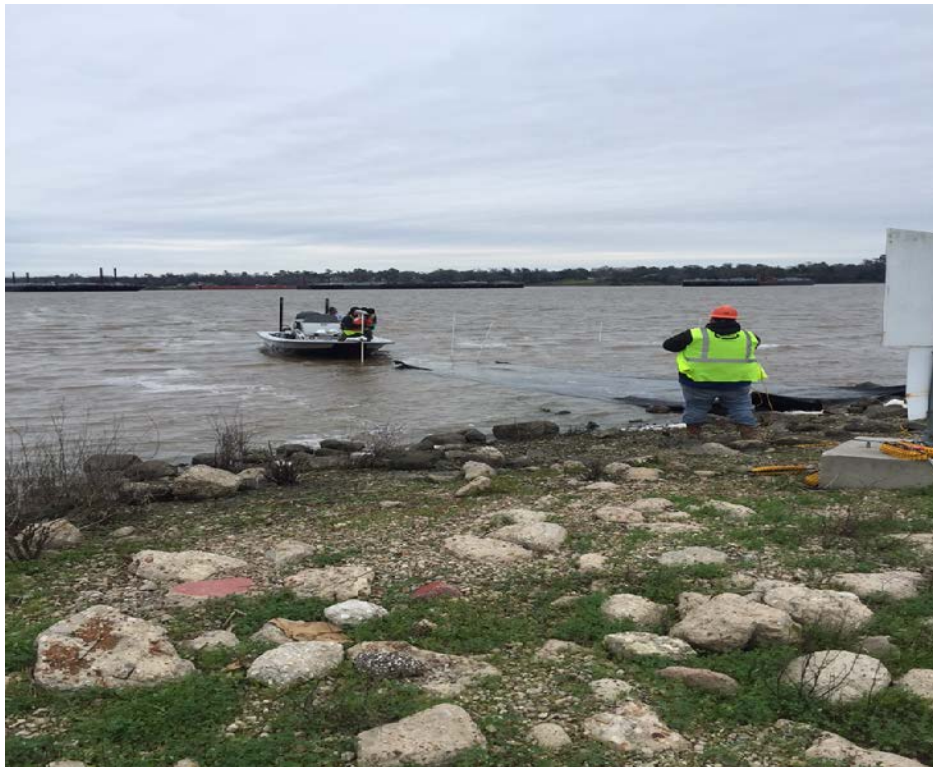
- USA Environmental experienced difficulty in getting the fabric from the shore to the WA. Several attempts were needed to get the proper boat orientation. The rip rap used to “pin” the north east corner of the fabric was dropped from approximately 10 feet, exceeding the work plan height of 2–3 feet.

30 December 2015: Attempting to place fabric in the area of concern.

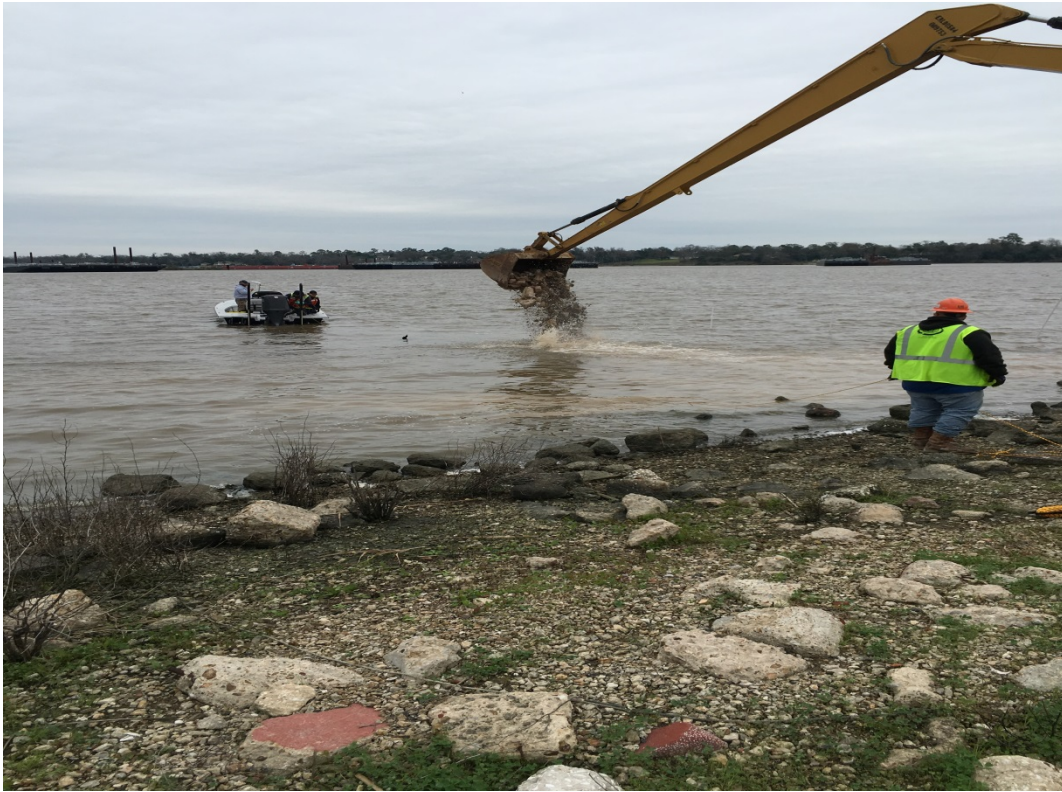
30 December 2015: USA Environmental dumping rip rap from over 3 feet.

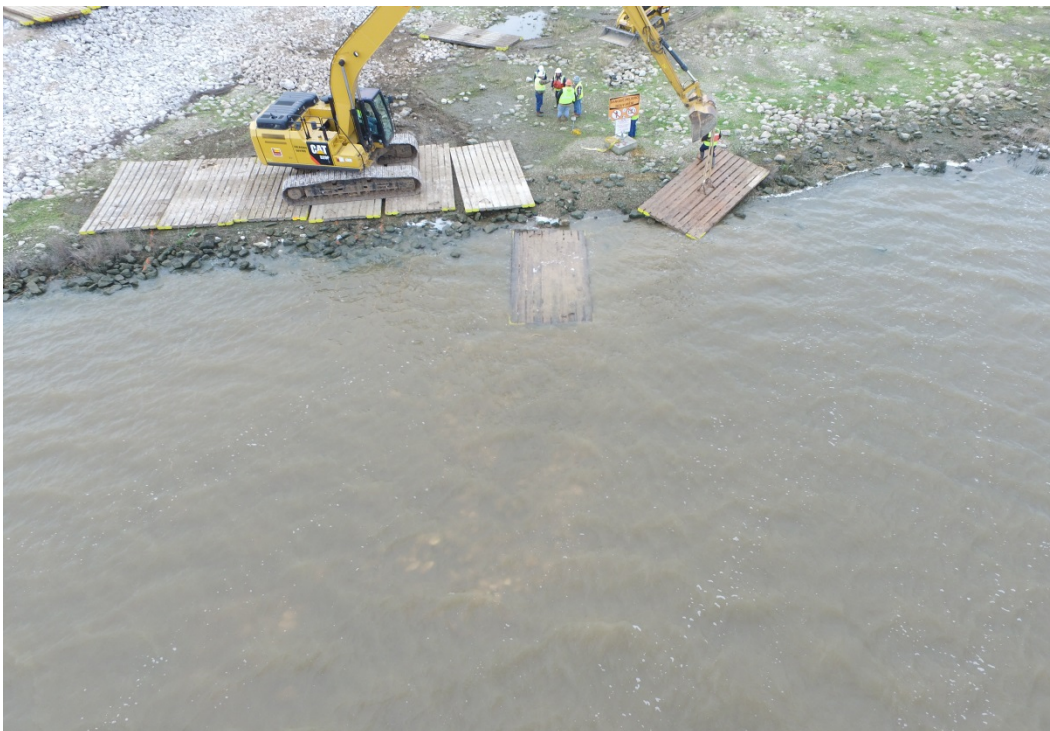
31 December 2015: USA Environmental staging crane mats for probing activities.

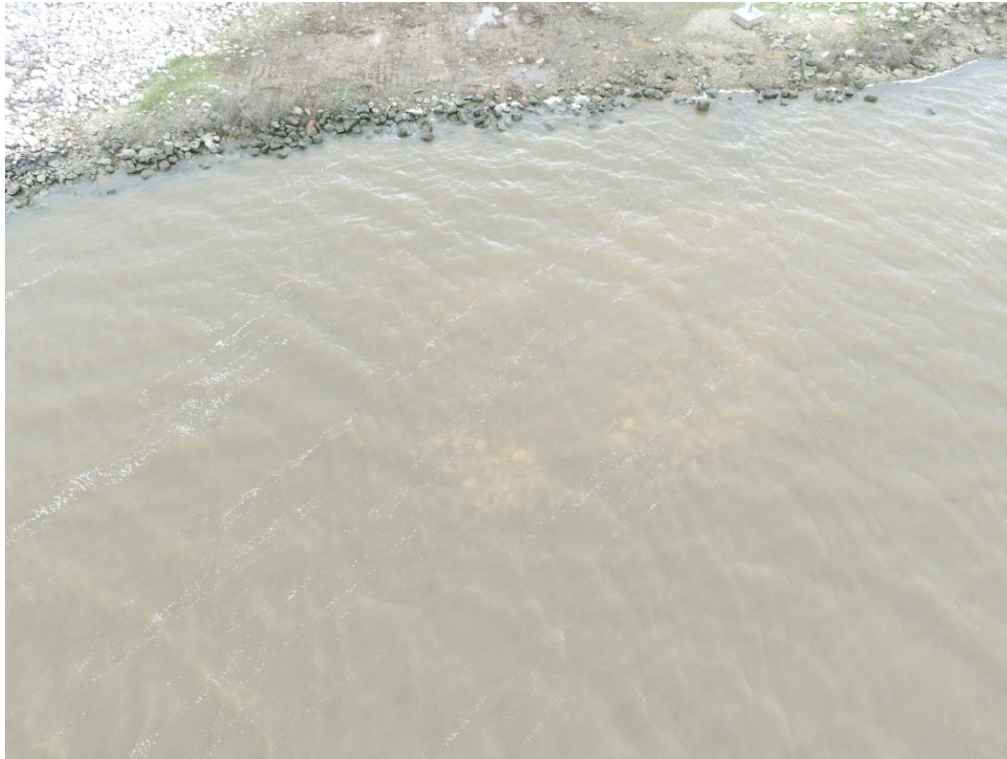
- USA Environmental continued placing fabric and rip rap until approximately 1700 hours. Due to the turbidity and lack of reference markers it is unclear if the rip rap achieved total coverage or 5 feet of overlap outside of the WA per the Anchor work plan.

31 December 2015: Cap status and probing NE-SE. Repair nearly visible beneath surface.

- At 0942 hours additional rip rap was placed at the western edge of the WA after probing measurements came up at a thickness of 9 inches.
- From 0942 hours until 1054 hours Anchor and USA Environmental continued probing, moving first east then north to cover the WA. Anchor and USA Environmental reported that the top of the rock was visible from the crane mats. EA attempted to use aerial photography to confirm the extent of the rip rap repair. The turbidity and roughness of the water prevented definitive images from the air above the cap. Photographic documentation obtained during the field activities are provided at the end of this report in Appendix A. Scanned pages of the field logbook are included in Appendix B.

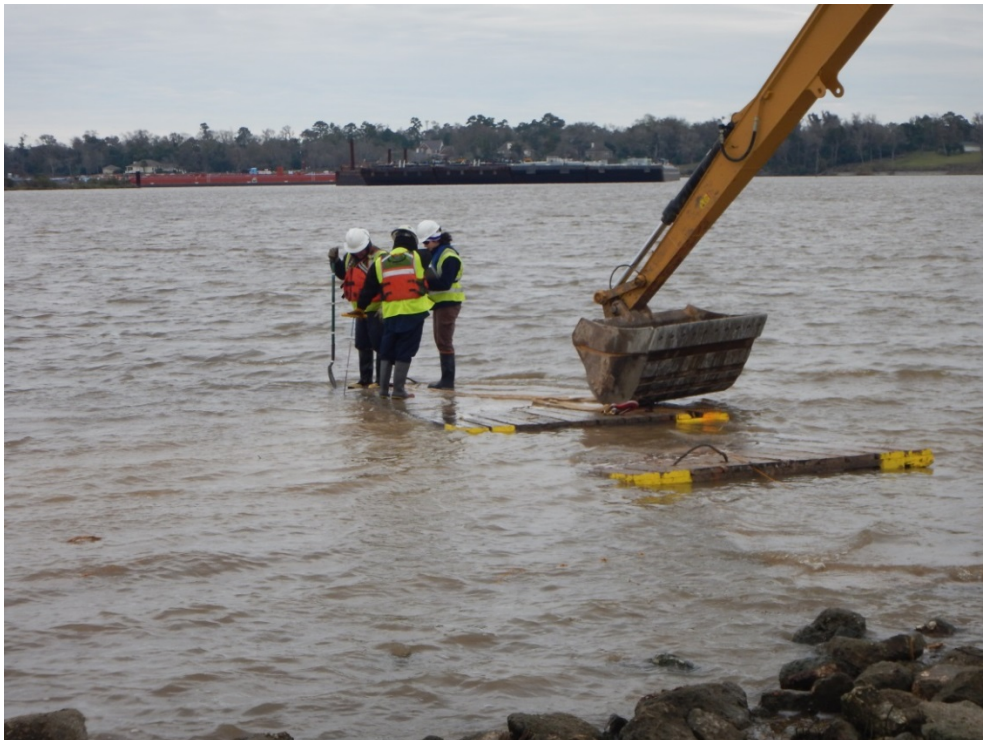
31 December 2015: Anchor and USA Environmental probing rip rap thickness.

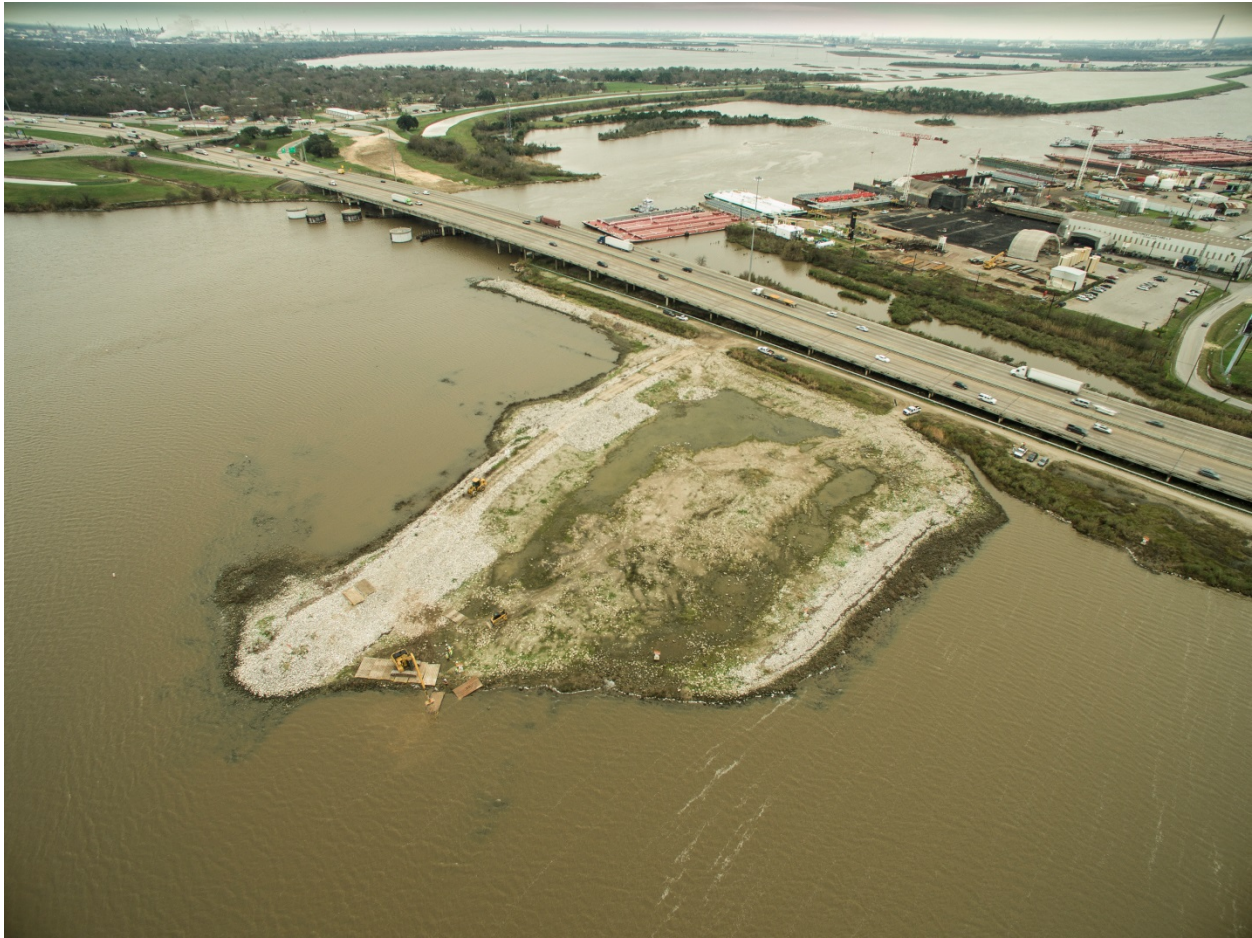
31 December 2015: Cap status and repair probing set up.
